TECHNICAL REPORT
ON
COASTAL EROSION IN KIRIBATI;
VISIT TO SOUTH TARAWA,
22 January - 10 February 1982
by
Russell Howorth

COASTAL EROSION IN KIRIBATI
VISIT TO SOUTH TARAWA
22 January - 10 February 1982

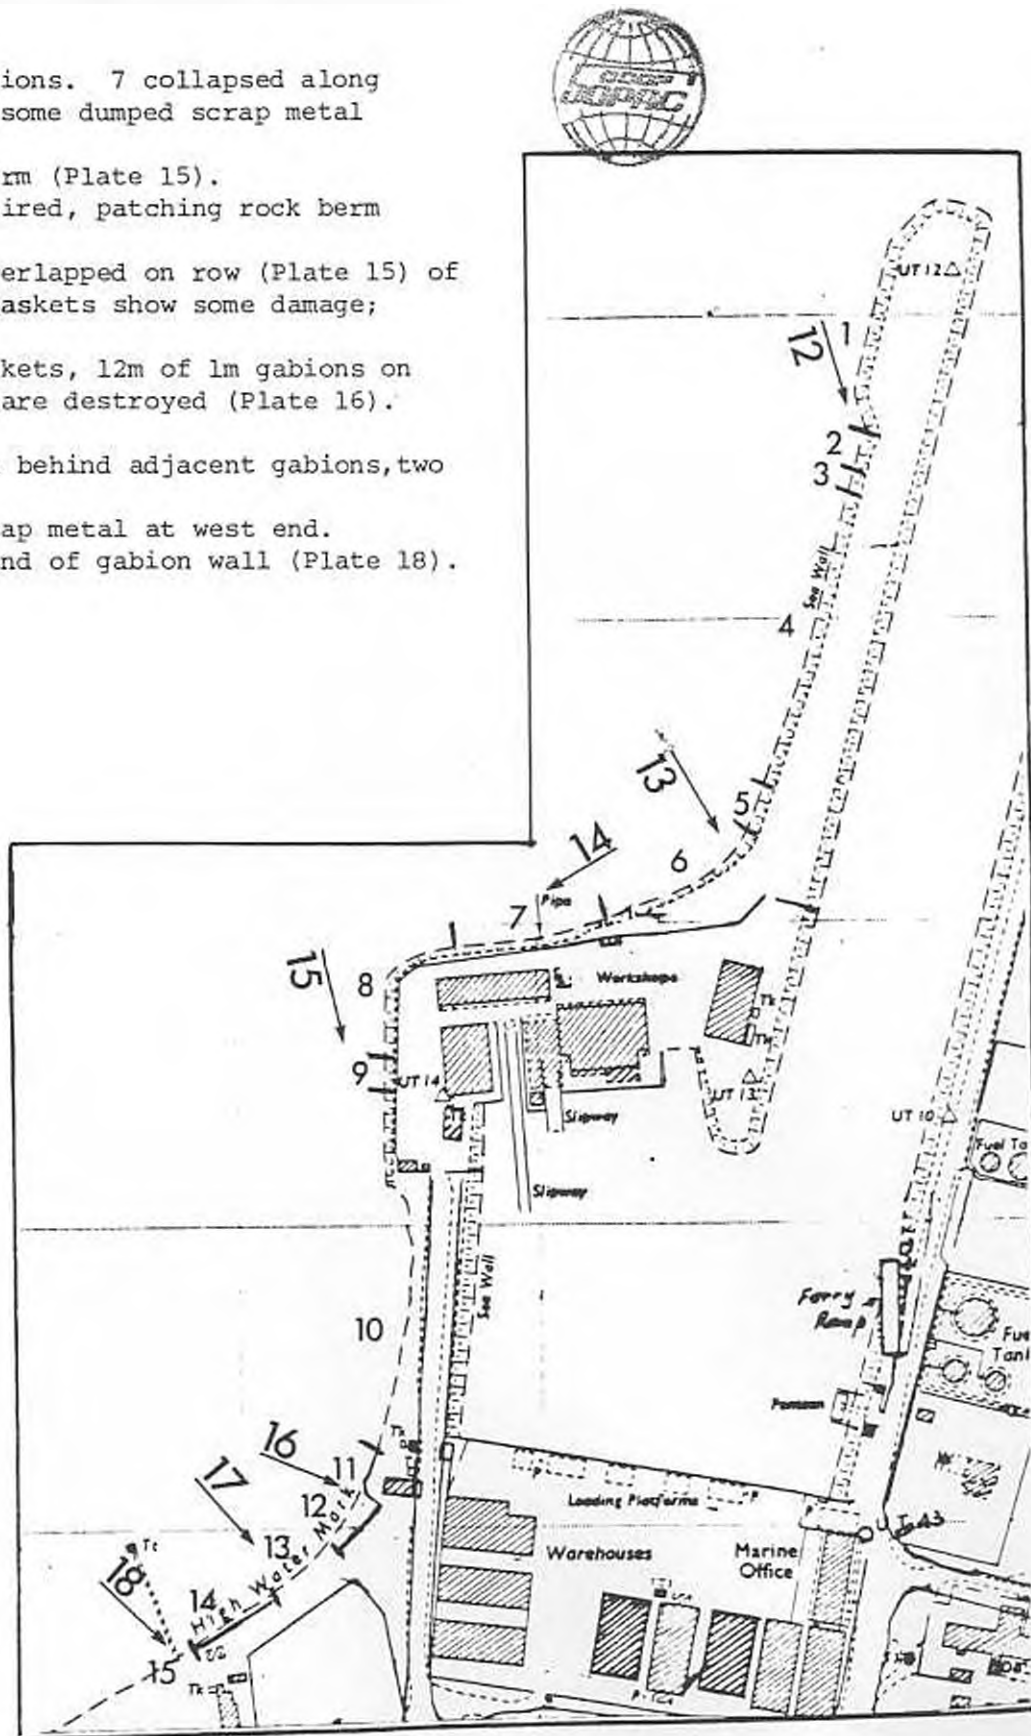
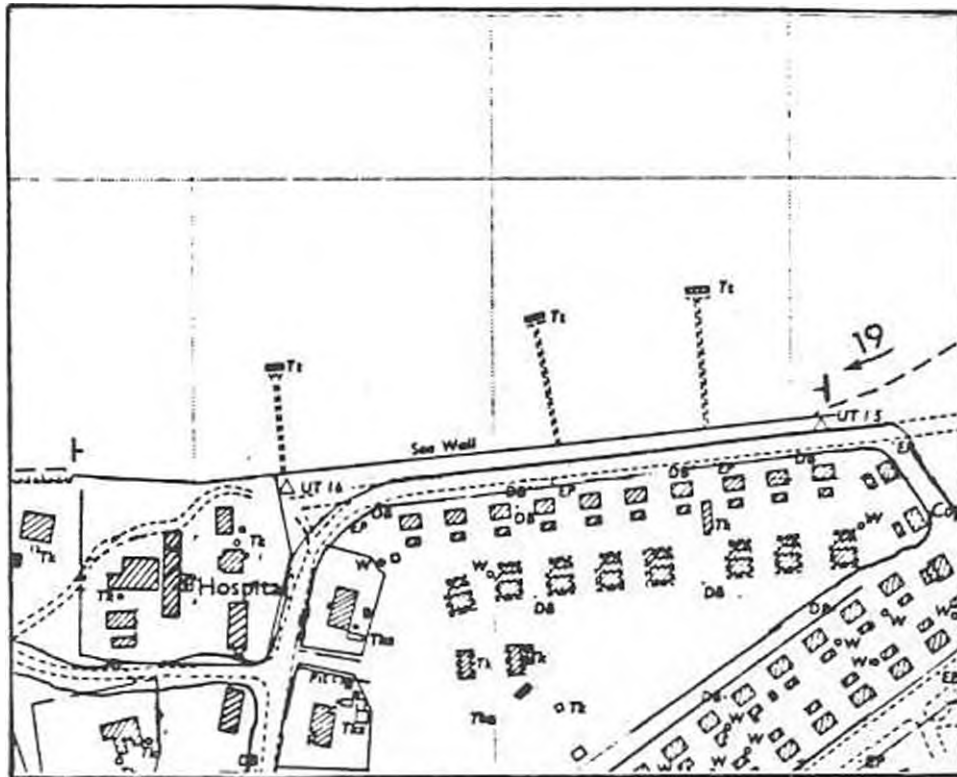
Betio CPZ 2

Vertical seawall up to 40cm thick; 1.5-2.0m high of cemented coral rock, coral heads and concrete. In 1978 wall in good condition showing no signs of erosion or accretion. In February 1982 wall in good condition, in one or two places local yard extensions for house sites existed in front of seawall (Plate 19).

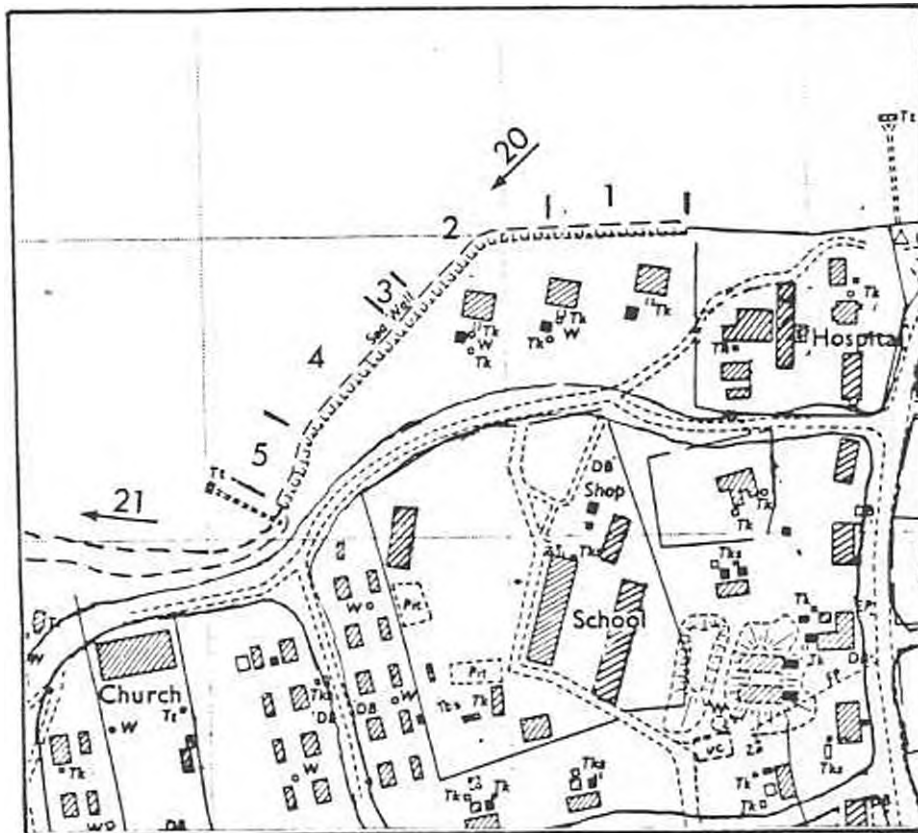
Betio CPZ 3

Original seawall uncemented concrete bag berm; only area 3 remains undamaged (Plate 20).

1. 36m of 1m gabions, existed in 1978, now damaged and repaired with 0.5m gabions.
2. 28m of 1m gabions in good repair.
3. Berm.
- * 4. 36m of 1m gabions, existed in 1978, now 7 need repair.
- * 5. 20m of 1m gabions, in good repair but some scouring behind.

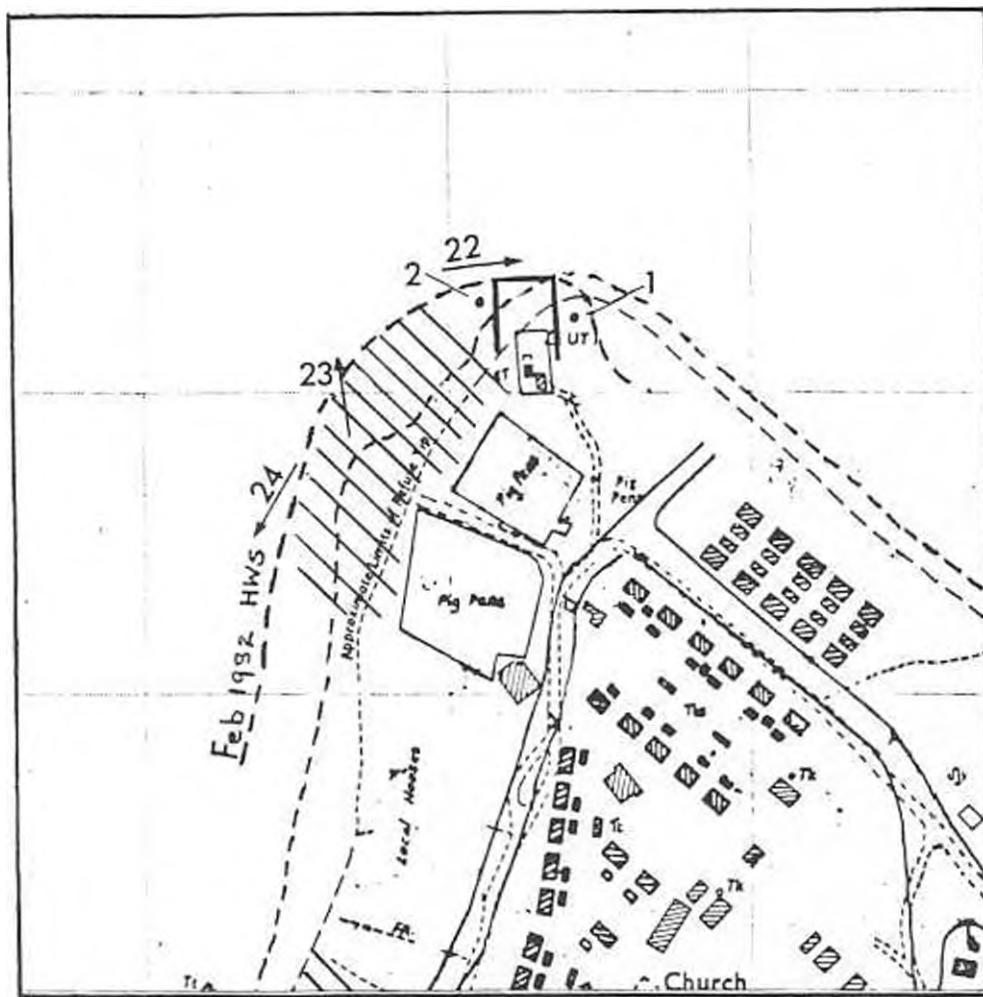
Betio CPZ 4

- * In 1978 20 1m gabions badly filled and slumped but not abraided. In February 1982 these baskets were in place, generally full but need repairs. 6 new gabions had been placed on top of existing gabions along front with one reno mattress at east corner, and two at west corner (Plate 22).
- * Te Makin Rubbish Dump (Plate 23, 24). It would be an advantage to control the emplacement of rubbish so as to minimise reworking onto reef platform at high tide. A scheme similar to that suggested by Holmes (1979) for Nanikai would be acceptable.
 1. Accretion burying gabions.
 2. Accretion since 1978.

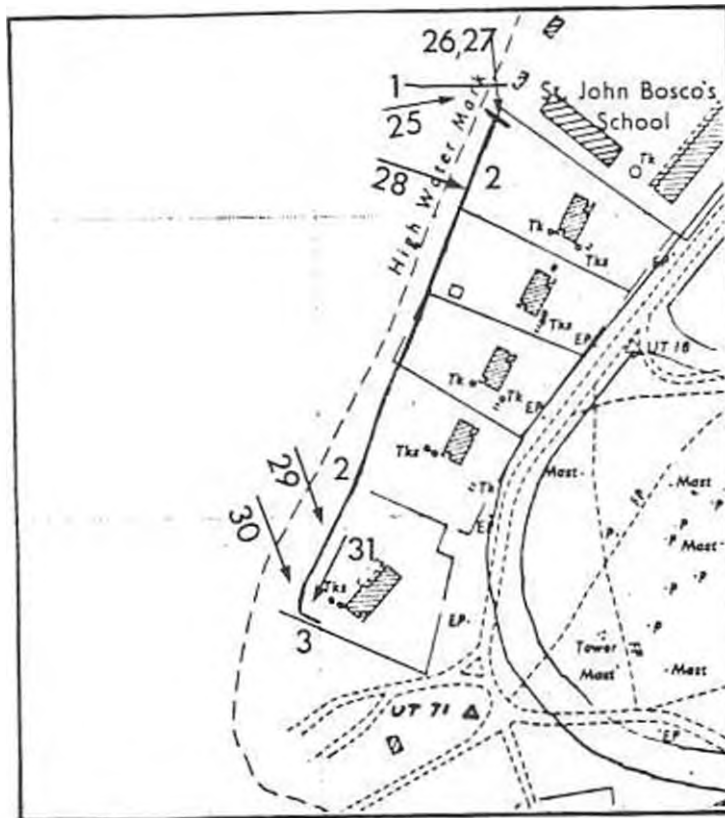
Betio CPZ 5

In 1978, 44m of southern end of a new gabion wall under construction, baskets loosely filled and distorted. Eventually completed for approximately 150m. Overtopped and badly damaged by high spring tides during period of westerly winds in December 1980.

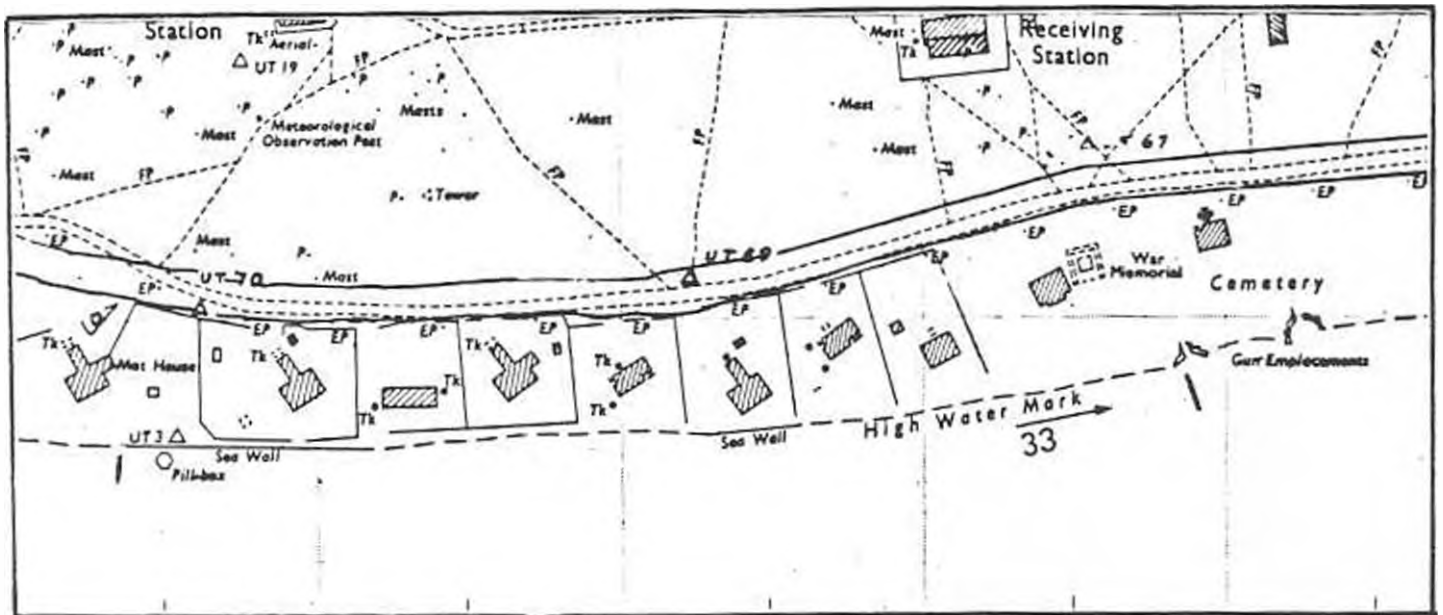
Betio CPZ 6

Date of construction of seawalls marked on 1972 base maps is unknown. These walls no longer evident, presumed buried. In 1978, 54m of 1m gabions in good repair at head of beach west of gun emplacements. 22m of gabions were clearly visible at east end, rest buried.

In 1982, gabions buried and grassed over (Plate 33) except for 10m at east end; 30cm of each basket visible.

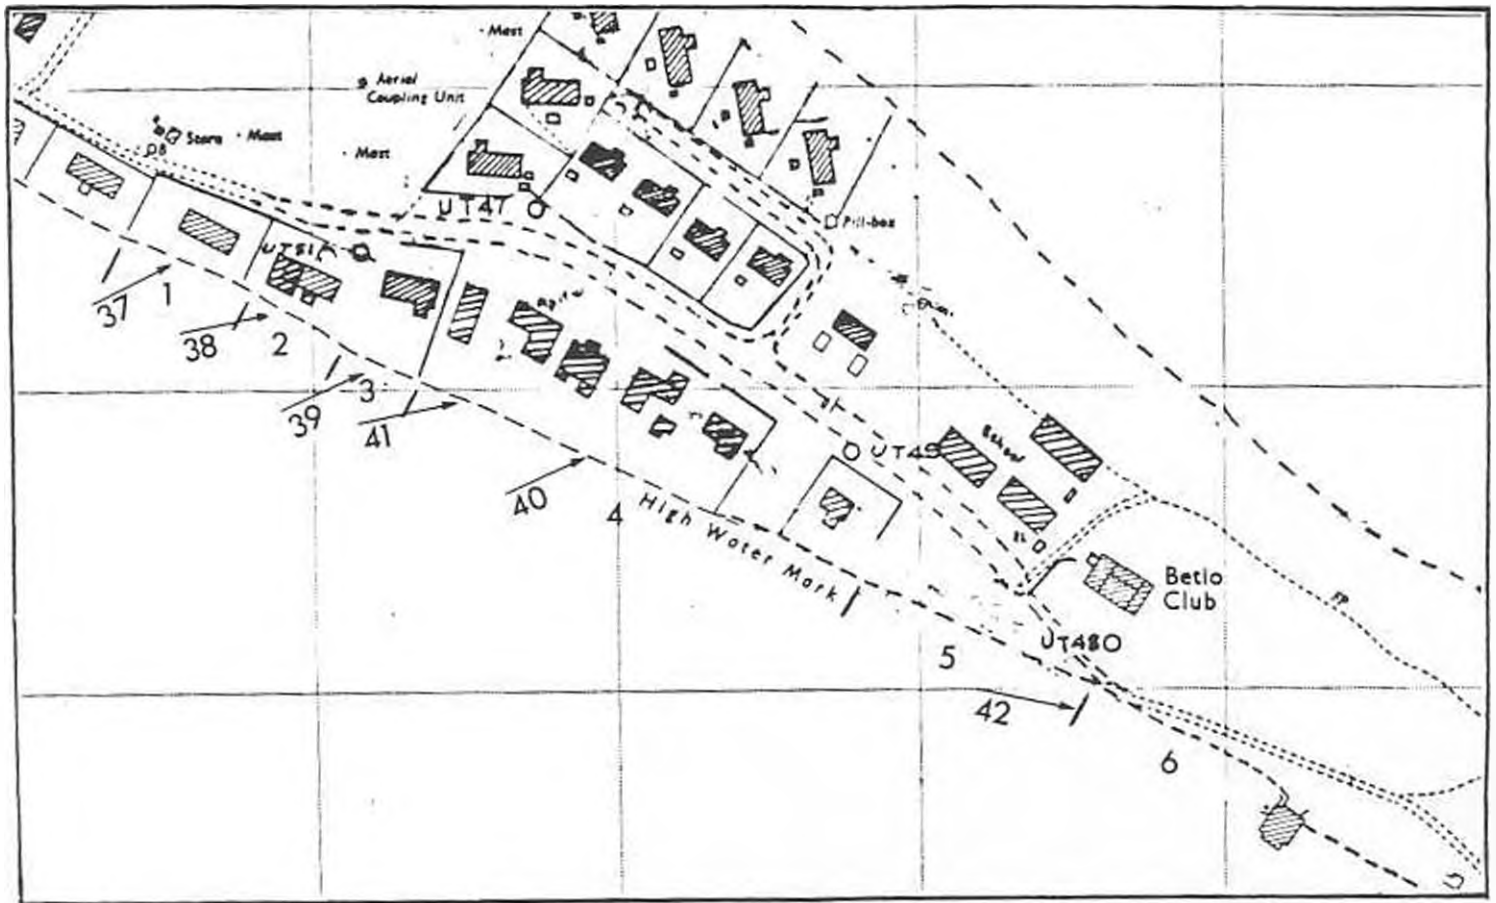
Betio CPZ 7

- * 1. Erosion occurring, 3m retreat in front of house and two trees lost (Plate 37).
- * 2. 38m of 1m gabions of which 3 are damaged and some being refilled, existed in 1978 (Plate 38).
- * 3. Gap for boat access, scouring around adjacent ends of gabion walls (Plate 39).
- * 4. 160m of 1m gabions of which 27 are damaged (Plate 40, 41).
- 5. Beach.
- 6. Former seawall to west of bunker marked on 1:1250 map (1972), now beach; wall presumed eroded (Plate 42).

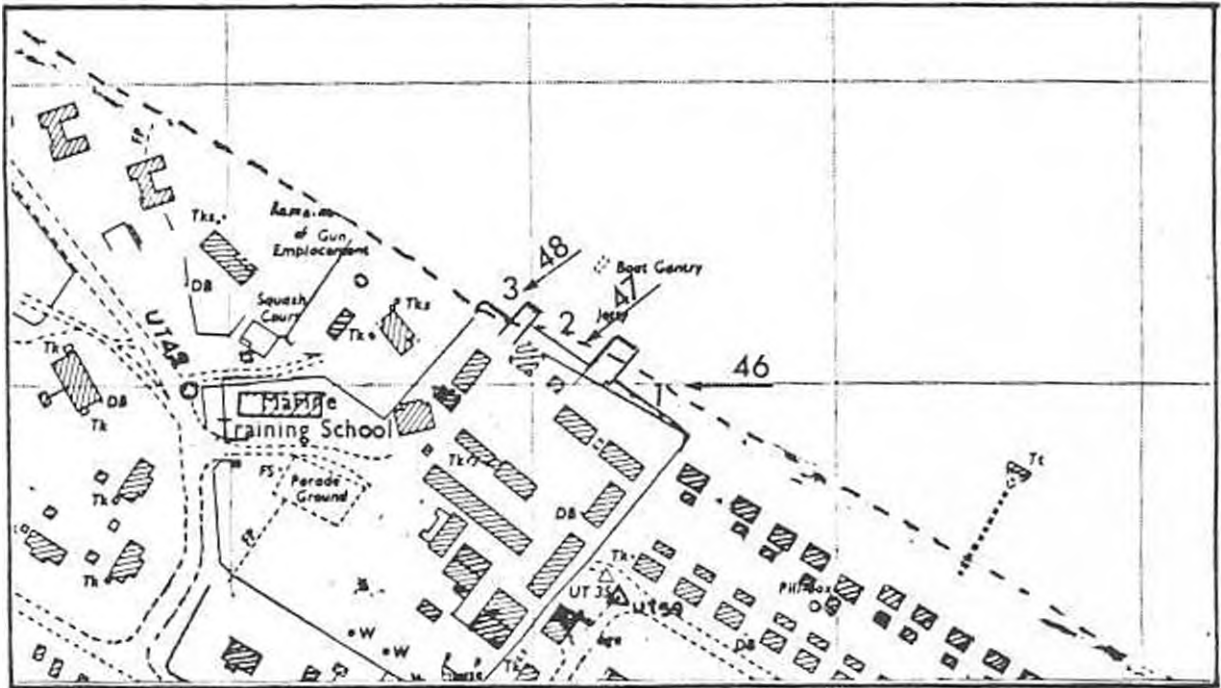
Betio CPZ 8

Gabions around boat ramp and jetty of Marine Training School.

- * 1. 14, 1m gabions around head of boat ramp, two alongside ramp broken (Plate 48).
- 2. Double layer of 10, 1m gabions (including two on jetty corner), lower layer cemented over except two covered in scrap metal, front face of upper layer exposed with top surface almost entirely cemented over (Plate 47).
- 3. What appears to be a layer of reno mattresses are now almost completely buried as a result of accretion (Plate 46).

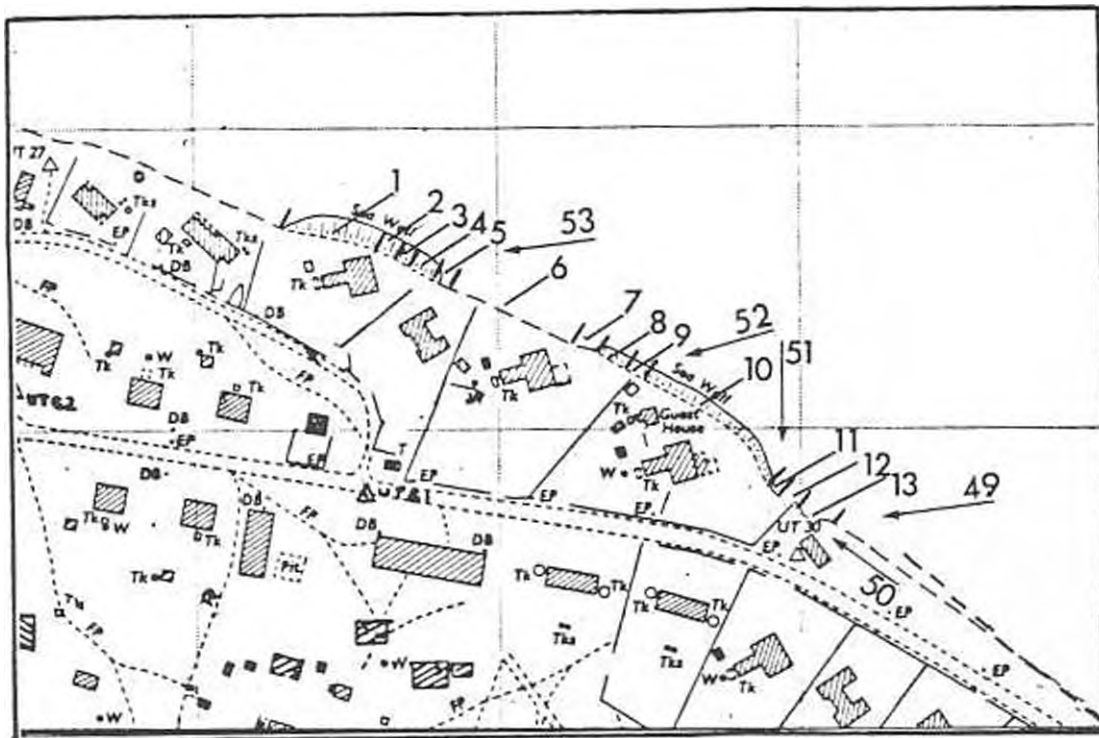
Betio CPZ 9

Original protection was a loose rock berm, now extensively modified by repairs.

1. 30m of 1m gabions (except one 0.5m gabion at east end), poorly filled and deformed but intact, some sand build-up at base, existed in 1978 (Plate 53).
2. c. 5m loose rock berm (Plate 53).
3. 4m of 0.5m gabions, new and well filled (Plate 53).
- * 4. 6m of 1m gabions, one broken at east end. Existed in 1978.
5. c. 7m loose cement bag berm (Plate 53).
- * 6. 42m of 1m gabions, five damaged, rest poorly filled (Plate 53).
7. c. 5m loose rock berm.
8. 10m of 1m gabions except one new 0.5m gabion at west end, 1m gabions existed in 1978 (Plate 52).
9. c. 10m rock berm (Plate 52).
- * 10. 58m of 1m gabions of which at least 12 need repair; existed in 1978 (Plate 51).
11. 6m of 1m gabions; new, almost completely buried by sand.
12. Beach, some large concrete slabs, some scouring in past.
13. 16m of 1m gabions almost completely buried, existed in 1978 (Plates 49, 50).

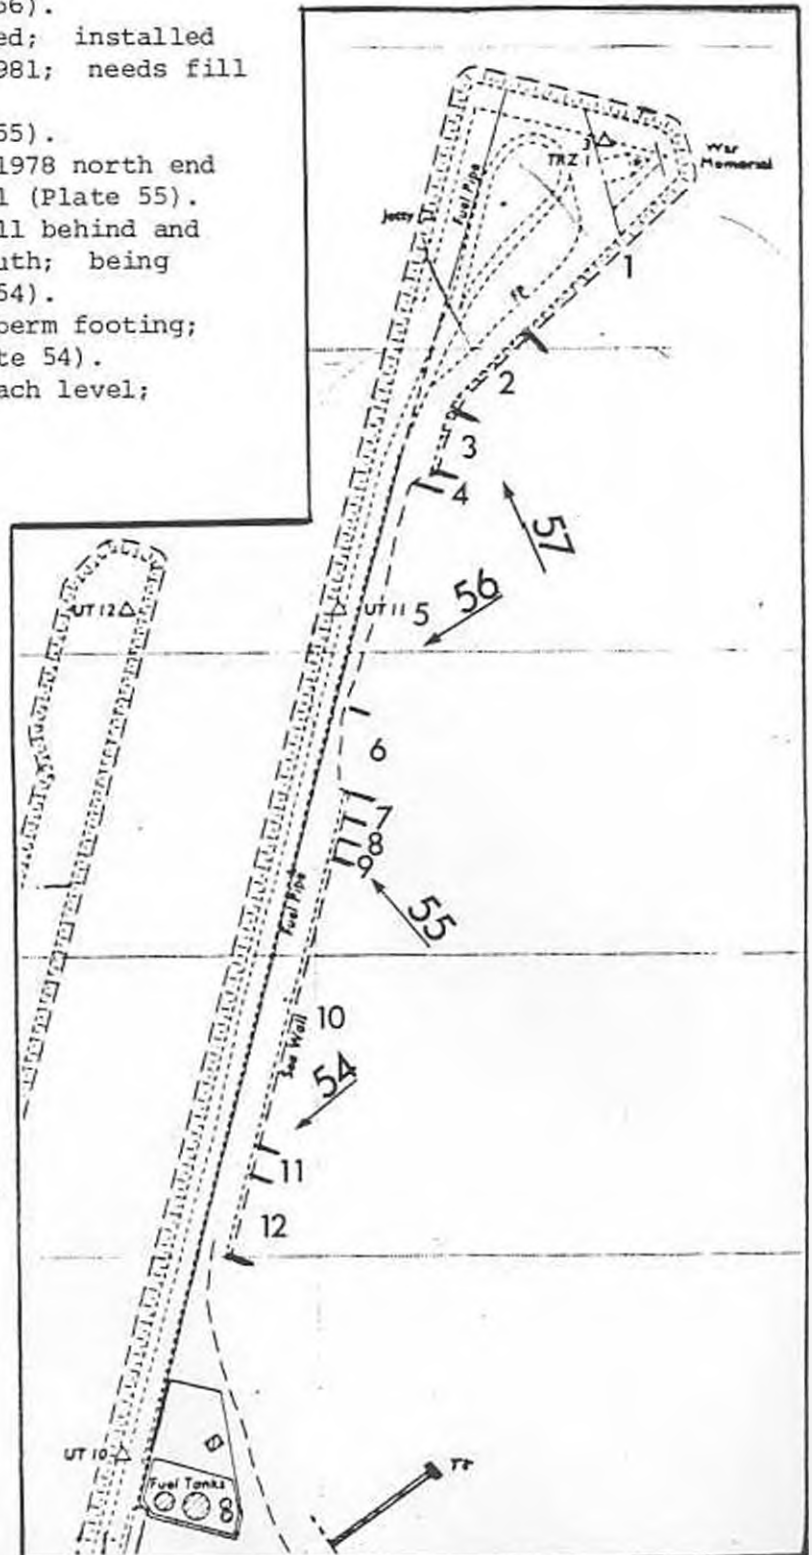
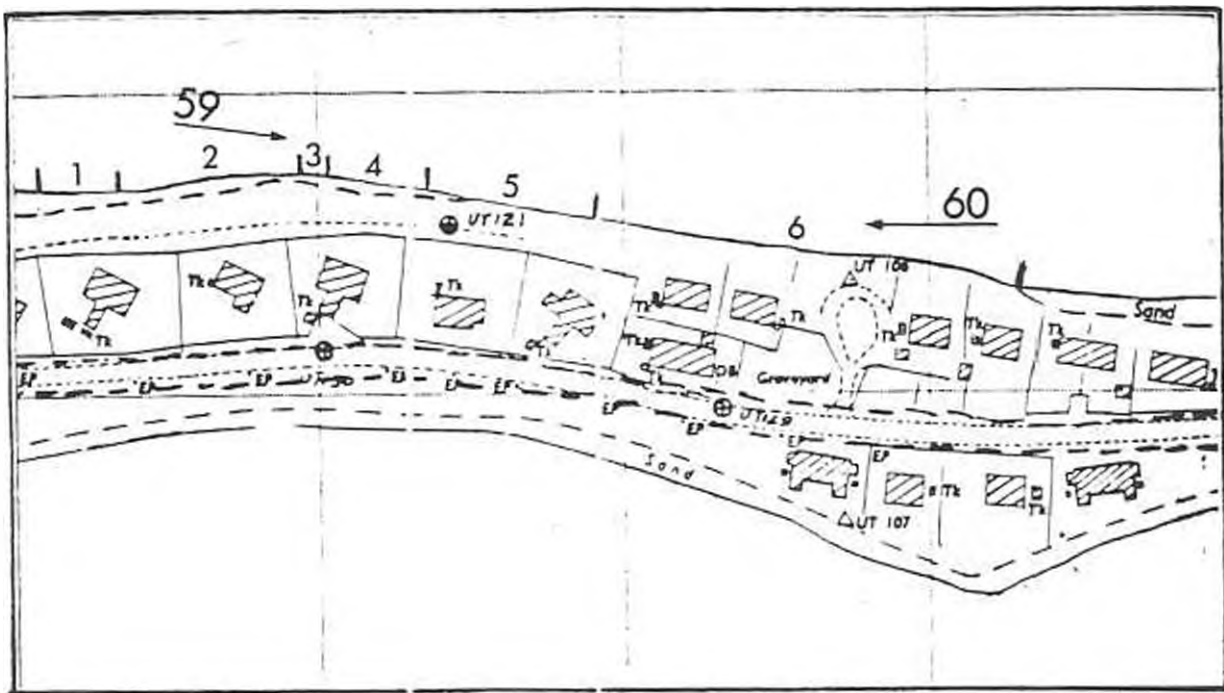
Bairiki CPZ 1

Original coastal protection was a low coral rock berm now extensively repaired, and generally showing some sand build-up at base.

- * 1. Deteriorated rock berm (Plate 59).
- 2. Rock berm on beach rock platform and/or sand.
- 3. Grouted rock wall.
- * 4. Poorly repaired rock berm.
- * 5. Repaired rock berm, deteriorated boat ramp separated 5 and 6.
- * 6. Repaired rock berm with sand build-up at base (Plate 60).

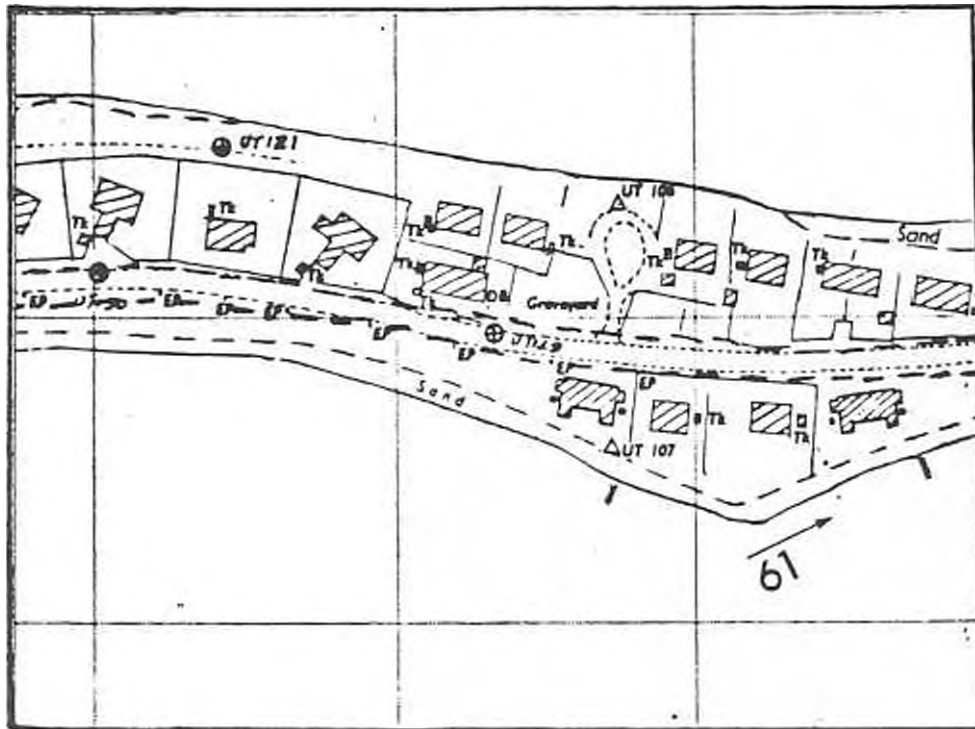
Bairiki CPZ 2

- * At present no protection exists. However, erosion is occurring along HWS line exposing tree roots in a 20-30cm scarpment along the frontage of three properties (Plate 61).

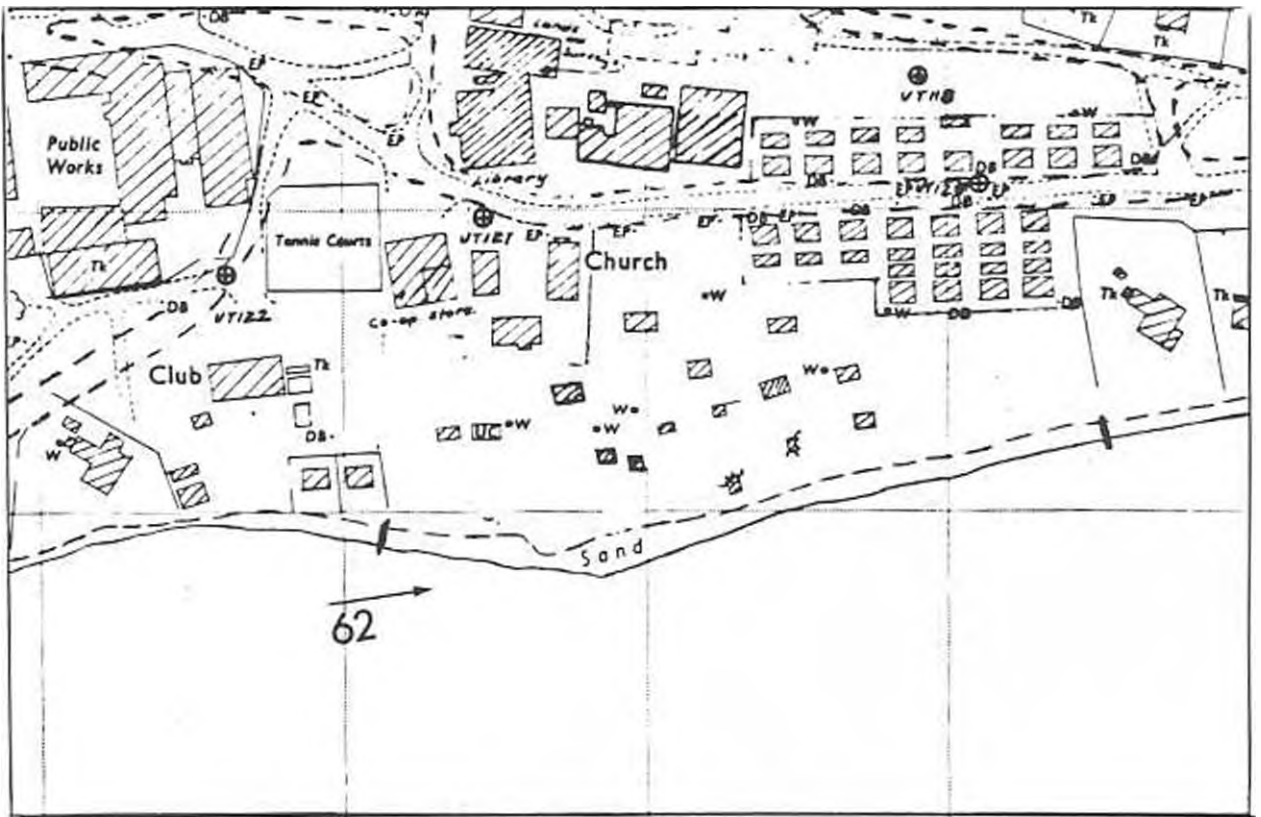
Bairiki CPZ 3

Beach frontage for Bairiki village community.
All along beach head villagers have taken their own precautions against erosion. Measures generally include a coconut log wall with dead vegetation packed in behind logs. Erosion does not appear serious at this point in time (Plate 62).

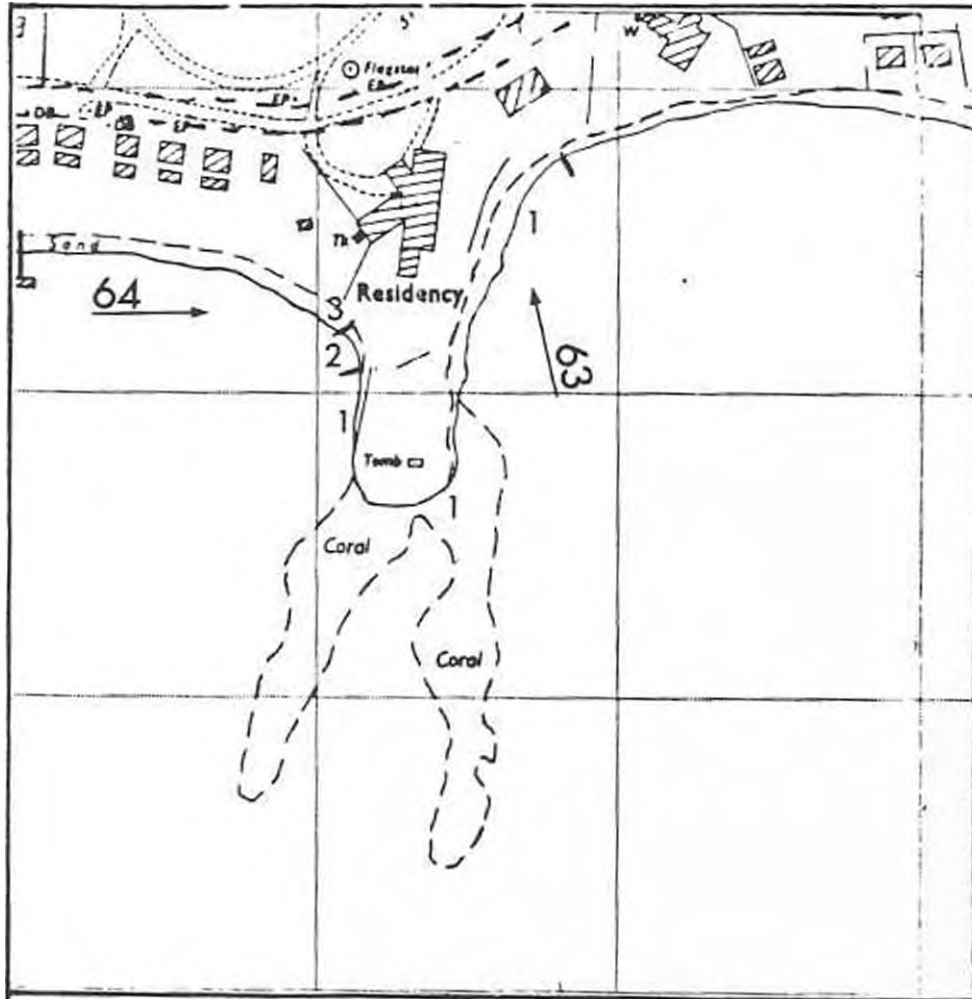
Bairiki CPZ 4

Residency Point protected by beachrock coral breccia platform, platform is being steadily broken up by scouring beneath it and then cracking into slabs. Seawall around point built onto platform.

- * 1. Low, vertical wall of loose coral rock and old concrete slabs around point, some scouring of tree roots behind wall at MWS tides (Plate 63).
- 2. 20m of new 1m gabions (2-3 years old), well filled.
- * 3. At west end of gabions natural beach profile exists but scouring occurring behind gabions (Plate 64).

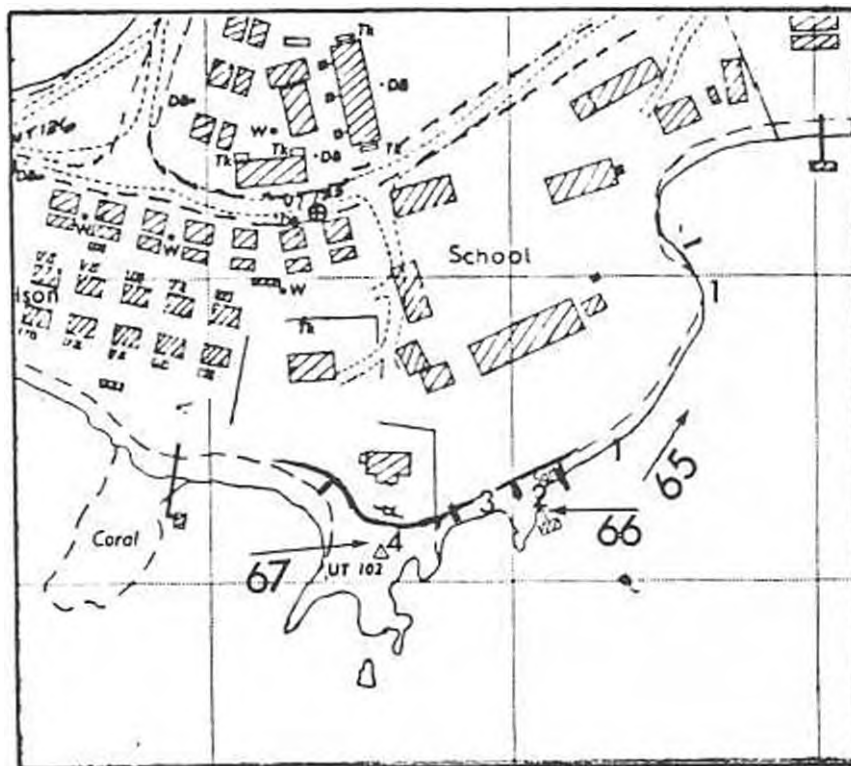
Bairiki CPZ 5

In 1978 this area, at Bairiki Primary School was being eroded, and a wall comprising a single layer of 1m gabions was being constructed. Erosion has continued and this gabion wall is now largely replaced by a loose vertical coral rock wall.

- * 1. Erosion occurring, exposing up to 1m from ground surface to beachrock platform, plenty of exposed roots, five coconut trees washed out (Plate 65).
- * 2. Loose, coral rock wall, 0.5-1.0m high, scoured behind.
- 3. 18m triple layer wall of 0.5m gabions, top 2 layers set back on bottom layer (Plate 66).
- * 4. New, loose coral rock vertical wall with 3 old gabions still to be replaced on point, at western end wall needs finishing into beach profile (Plate 67).

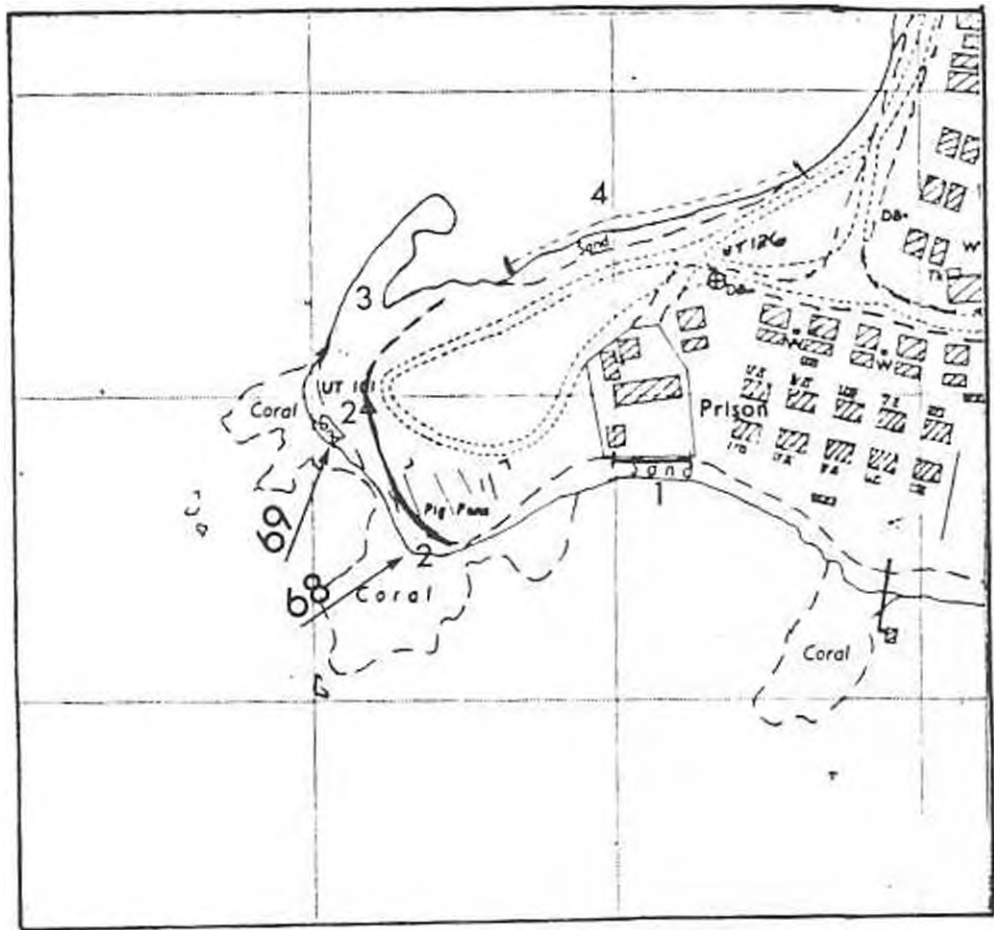
Bairiki CPZ 6

Southwest corner of Bairiki, shape of coast controlled by position of beachrock coral platform. Recent blasting of this platform during construction of outlet for new Bairiki sewerage scheme has disturbed the platform and resulted in up to 20m recession of the coastline at the pig pens.

1. Loose coral rock wall built by prisoners during late 1981; already collapsed because of bad construction.
- * 2. Loose vertical coral rock wall being built around point, using large platey coral rock broken from beachrock platform by blasting; stacking of rock as vertical "plates" following local practice, north end of wall needs profiling to beach (Plates 68, 69).
3. Sand spit no longer exists, eroded following blasting of reef platform.
- * 4. Sandy reef platform reclaimed by prisoners.

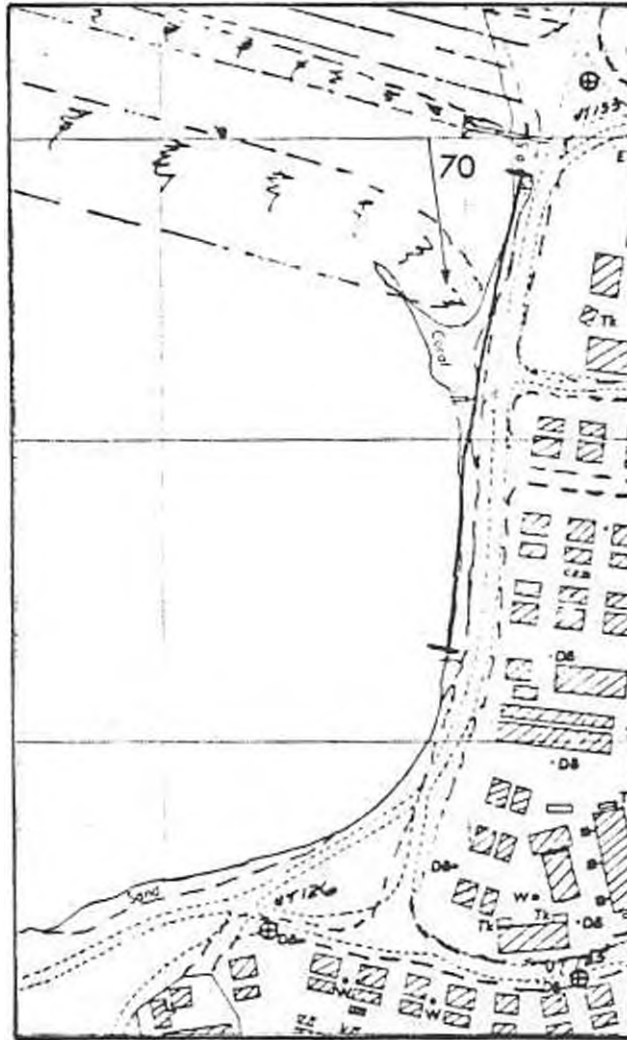
Bairiki CPZ 7

Close to Bairiki end of proposed road
causeway to Betio.

- * Poor attempt at loose coral rock seawall
and backfill to protect road needs
upgrading though some build-up of sand
has occurred. In 1979 sand filled bitumen
drums were being used for protection (Plate 70).

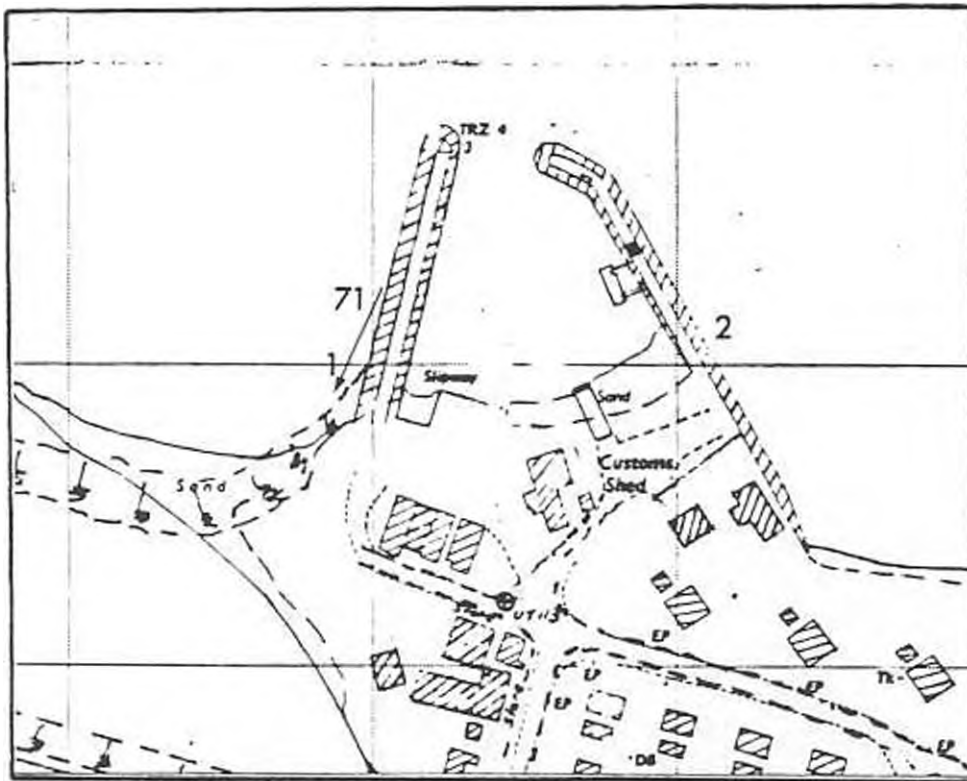
Bairiki CPZ 8

Bairiki harbour moles generally concrete bag berms.

- * 1. Erosion on southwest end of mole, 16m gabion wall c. 2.5m high extending from end of mole, and 15m low wall, original gabions largely collapsed and grouted stone wall erected, some gabions repaired (Plate 71).
- * 2. East mole has been repaired, at present only one small area in need of repair.
