geothermal well  
inspection

State of Hawaii  
DEPARTMENT OF LAND & NATURAL RESOURCES  
Division of Water & Land Development

GEOHERMAL WELL INSPECTION

WELL NAME/NO.: Kapoho State 1-A

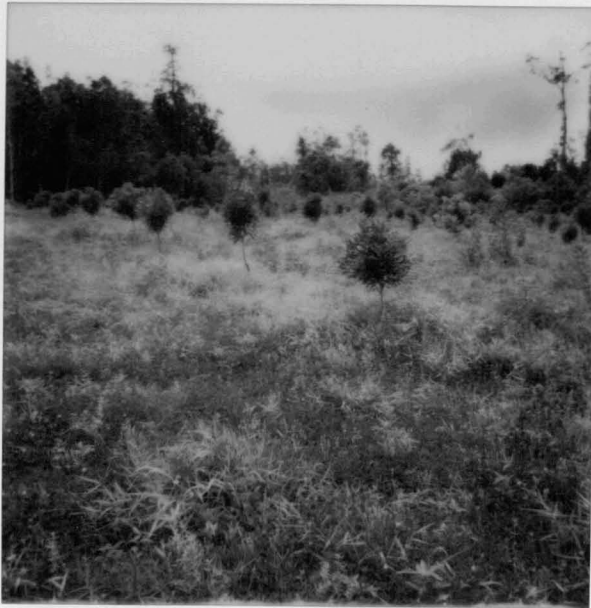
LANIPUNA NO. 1, ORIGINAL ACCESS  
ROAD TO WELL PAD. 9-10-87

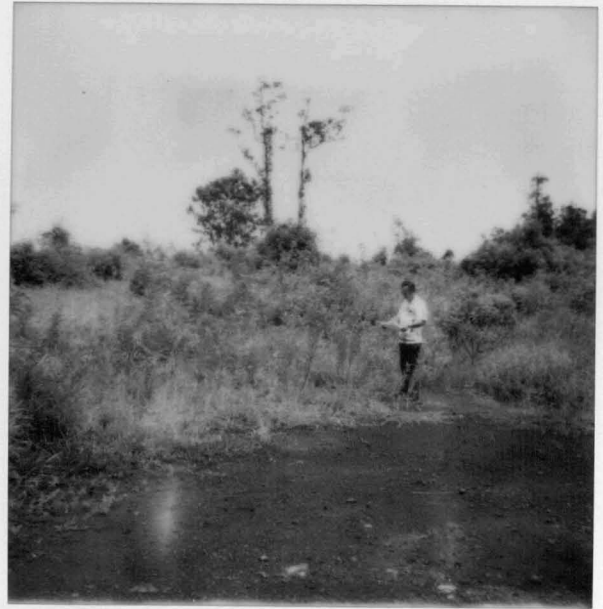
LANIPUNA NO. 1, WELL PAD  
AREA. 9-10-87

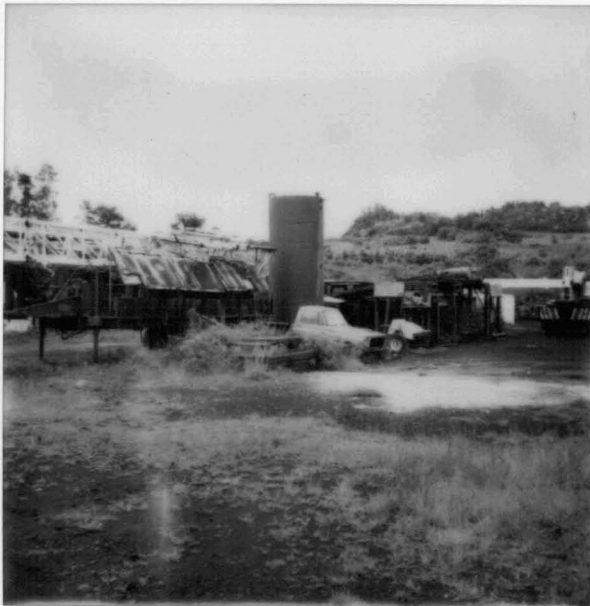
LANIPUNA NO. 6, WELL PAD  
AREA. NOTE - WELL DRILLING  
EQUIPMENT ON SITE. 9-10-87

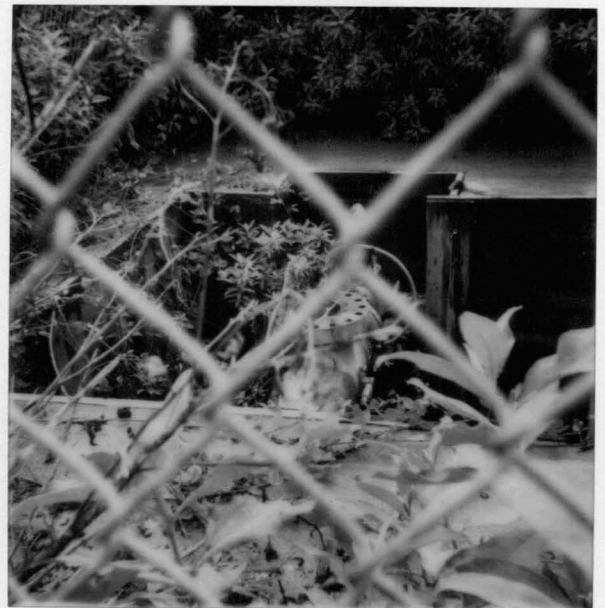
LANIPUNA NO. 6, VIEW OF  
CONC. CELLAR AND WELLHEAD  
THRU FENCE. 9-10-87

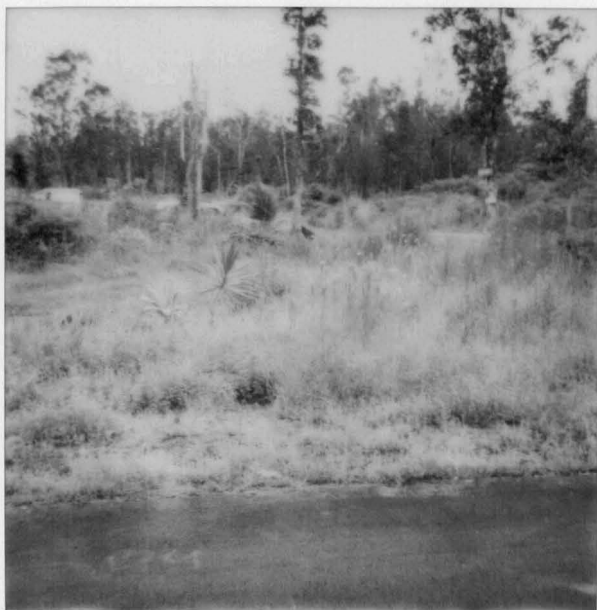
LANIPUNA I  
10-15-87 NO "TRESS PASS"  
HOUSE IN BACK SIGN ON TREE
