OESI Power Corporation

Subj: REPORT ON UNCONTROLLED FLOW EVENT AS PER CONDITIONS #13
 AND #26, ATC NO. A-833-795, ATTACHMENT II, WELLFIELD

PUNA GEOTHERMAL VENTURE

**REPORT ON UNCONTROLLED FLOW EVENT AS PER
CONDITIONS #13 AND #26,
ATC NO. A-833-795, ATTACHMENT II, WELLFIELD**

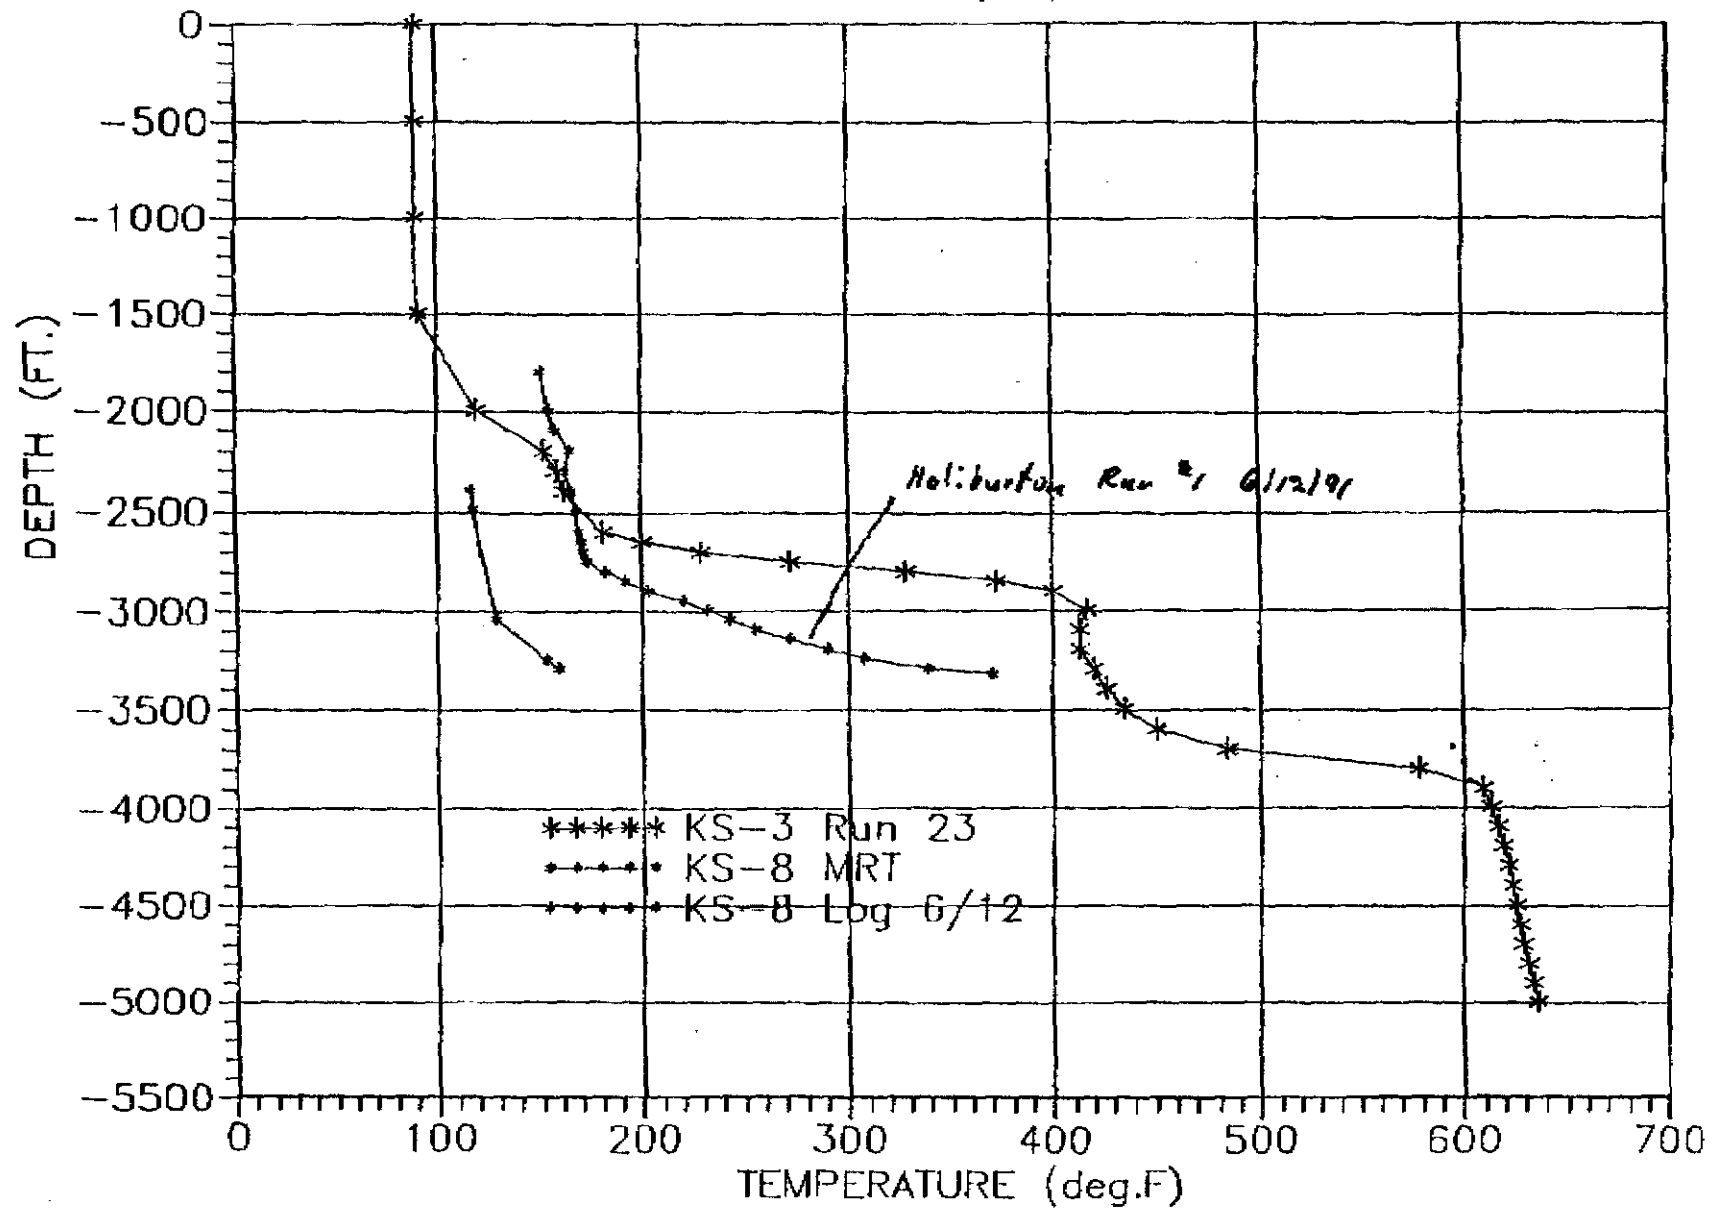
PUNA GEOTHERMAL VENTURE
KS-3: TEMPERATURE VS DEPTH
PRUETT RUN 23, 6/5/91

Two HLS logging services logging runs were run, temperatures were continually displayed in the HLS logging truck and recorded on both magnetic tape and a standard paper temperature log. Well KS-8 was logged to a depth of 3325 ft., the top of cement at this time was at 3350 ft. The logging tool was not allowed to run into the bottom of the hole in order to avoid becoming stuck in the cement at 3350 ft. The first temperature logging run encountered a maximum temperature of 370 degrees F. at a depth of 3325 ft. The temperature data was plotted on a graph of depth vs. temperature, on the same graph a temperature graph of well KS-3 was also plotted to obtain correlation between KS-8 and KS-3. (Graphs are part of this report).

A temperature correlation was obtained between KS-3 and KS-8 and it was determined from the correlation that based on temperature well KS-8 encountered temperatures equivalent to well KS-3 but at a depth of approximately 550 ft. deeper in well KS-8; ie, the temperature of 370 degrees F. encountered in well KS-8 was encountered at a depth of 3400 ft. whereas the temperature of 370 degrees F. was encountered in well KS-3 at a depth of 2850 ft. At the conclusion of HLS temperature log run # 1 while pulling out of the hole and attempting to log up the hole the HLS tool failed most likely because of excess temperature. (HLS wire-line was rated to a max temperature of 500 degrees F.)
