FLOOD PLAIN INFORMATION STUDY KAUMANA - PUNAHOA, HAWAII, HAWAII

FEBRUARY 1965

MAIN REPORT

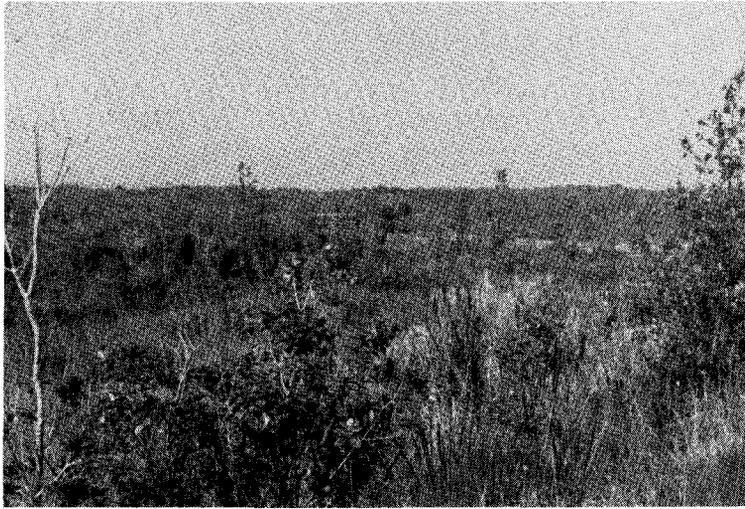
Figure 2.
At western end of study area looking towards Hilo Bay.

The Kaumana-Punahoa district is about 2 miles southwest of central Hilo and is on the northeastern slope of Mauna Loa (see plate 1). The study area comprises about 6,800 acres with an average ground slope of about 300 feet per mile and is situated between elevations 400 feet and 2,000 feet above mean sea level. The 1960 population was about 3,600, or 10 percent of the total city of Hilo population. Four new subdivisions are presently under construction; two on interior land between Kaumana Drive and Ainako Avenue (see figure 1); one adjacent to Kaumana along Wilder Road; and one above the town of Kaumana near the Hilo Country Club. Plate 2 shows the approximate areas described. About 85 percent of the area is covered by sugarcane fields, heavy forest and dense small shrubs and grasses (see figures 2-5).

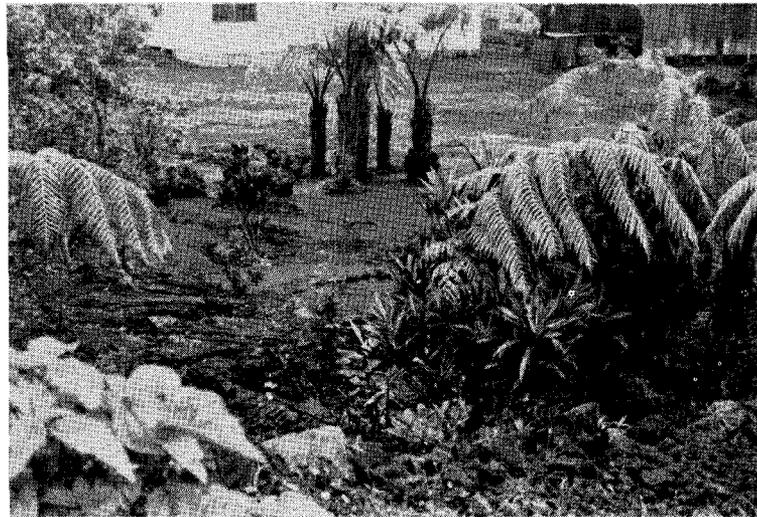
Figure 11.

The lava flow of 1881, the last flow through the Kaumana-Punahoa area, caused underground lava tubes to form and left porous soil behind. Figures 11-13 show some lava formations and a lava tube opening. The area however, does not have enough large lava tubes to affect major flood runoff.

At Kaumana Drive Station 4.4 - lava flow in yard

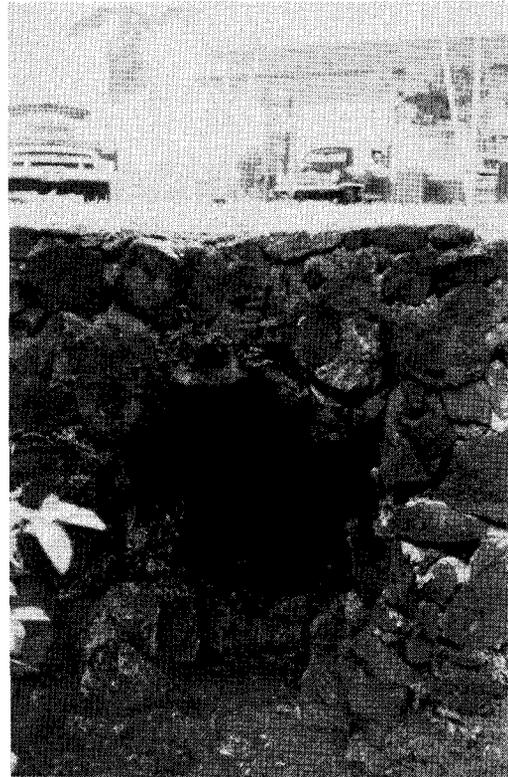
Figure 13.

At Kaumana Drive Station 6.3 -
lava tube opening below gas station

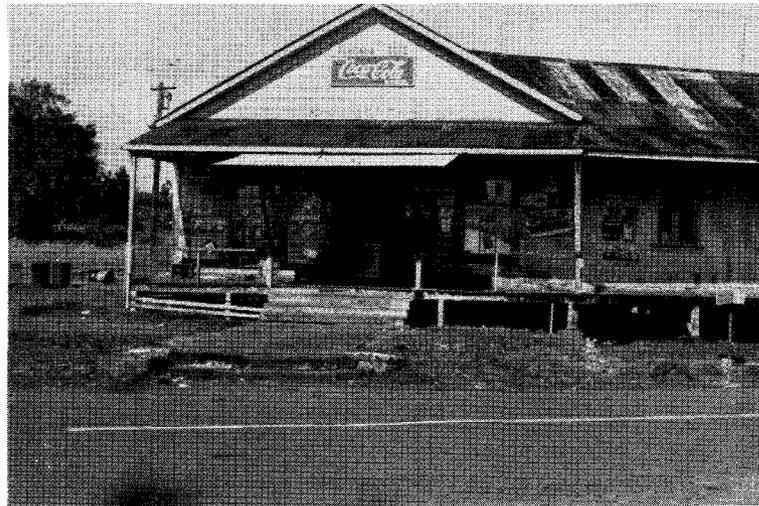
Figure 18.

At Piihonua store - northern part of study area - highest water in
30 years was 3 feet over the road

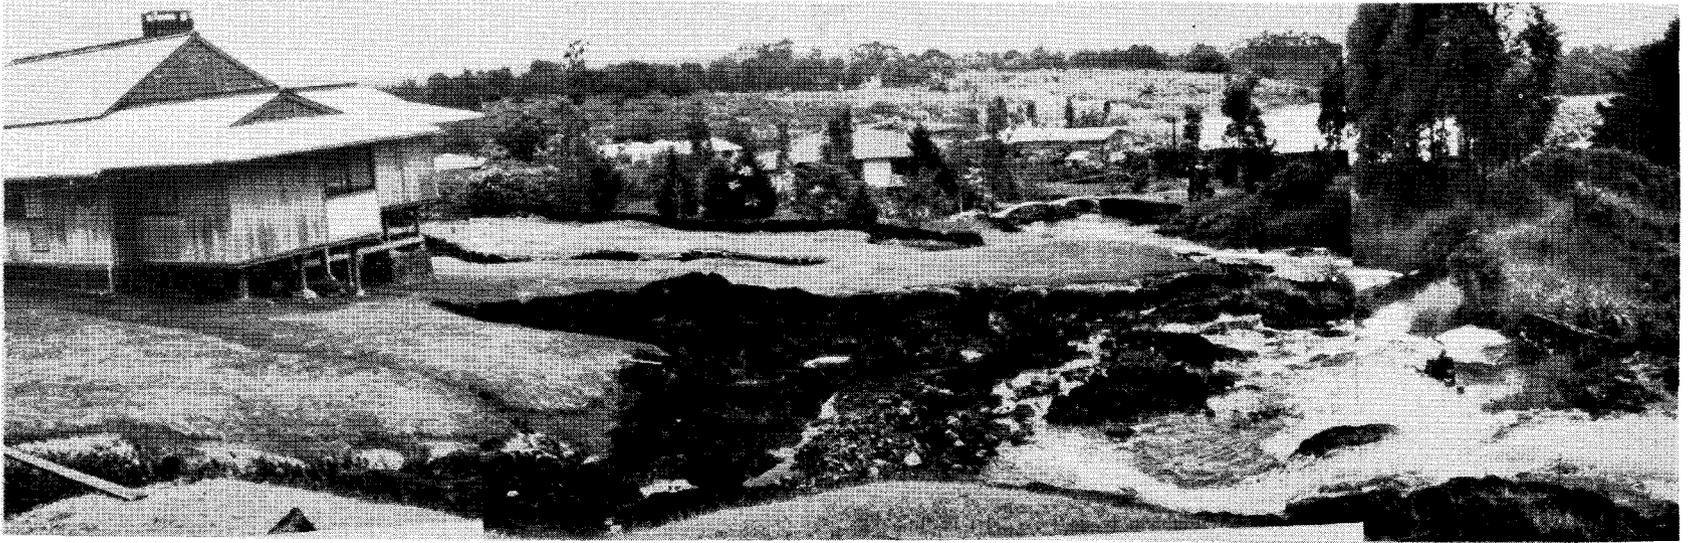
Figure 19.

On Koula Street at point 500 feet north of Ainako Avenue Station 2.9 - looking down the slope at water flowing through yards over a bed of lava rock
