TECHNICAL REPORT
ON
COASTAL EROSION IN KIRIBATI;
VISIT TO SOUTH TARAWA,
22 January - 10 February 1982
by
Russell Howorth

COASTAL EROSION IN KIRIBATI
VISIT TO SOUTH TARAWA
22 January - 10 February 1982

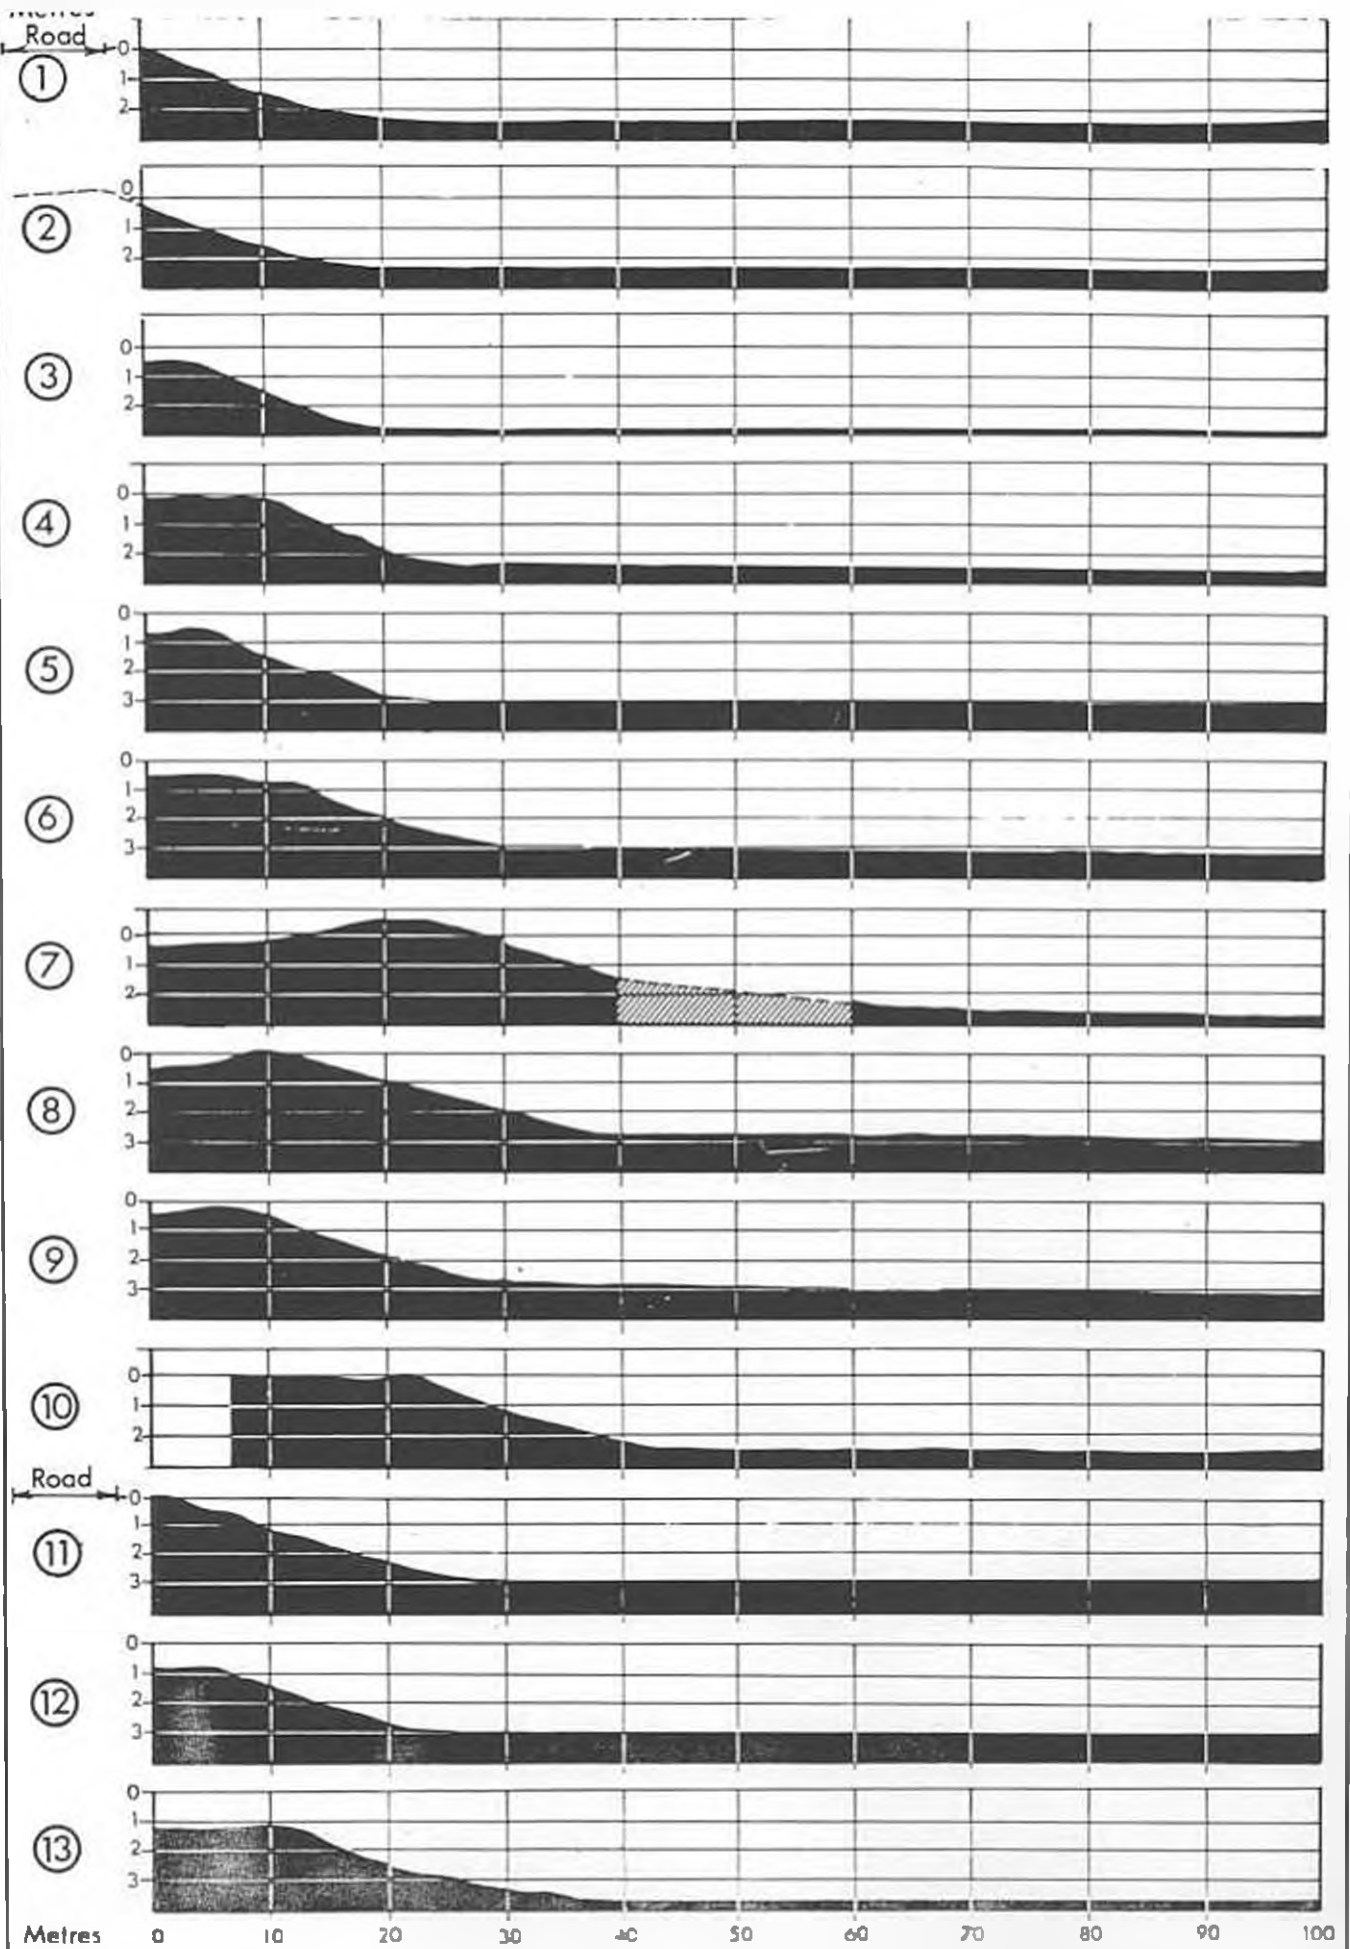
FIG.4

A total of 11 beach profiles in Bairiki and 13 in Betio were levelled in February 1982 (Figs. 4 and 5). Rather than put in datum pegs which are subject to local curiosity, care was taken to use fixed points (concrete) within the present environment.
